#### FINAL REPORT

# FRICTION EFFECTS OF RUNWAY GROOVES, RUNWAY 4R-22L JOHN F. KENNEDY INTERNATIONAL AIRPORT - PHASE II

PROJECT NO. 510-003-07X

REPORT NO. NA-69-8 (DS-69-3)

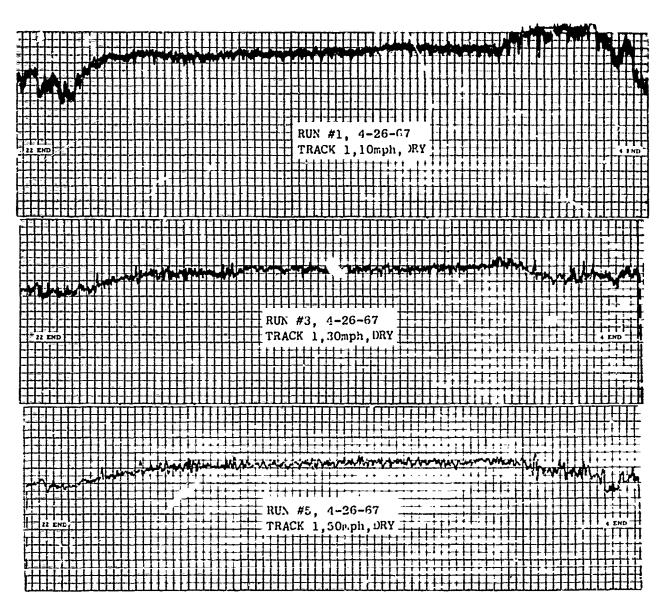
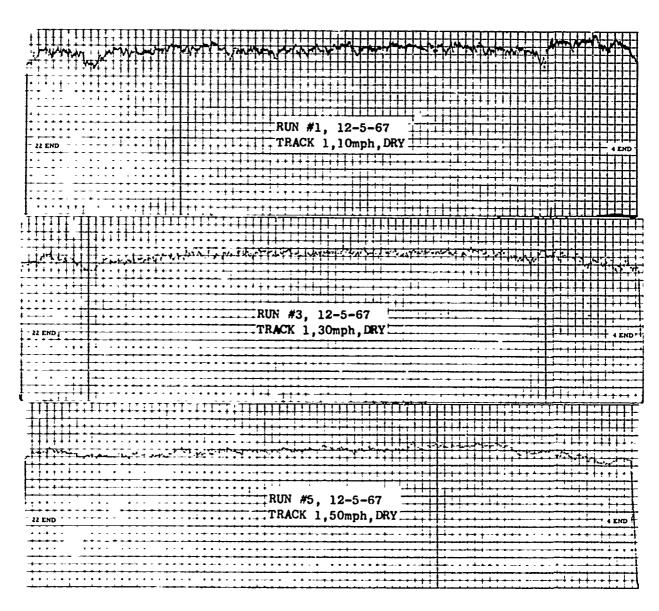
BEFORE GROOVING - TRACK 1, CENTERLINE

AFTER GROOVING - TRACK 1, CENTERLINE

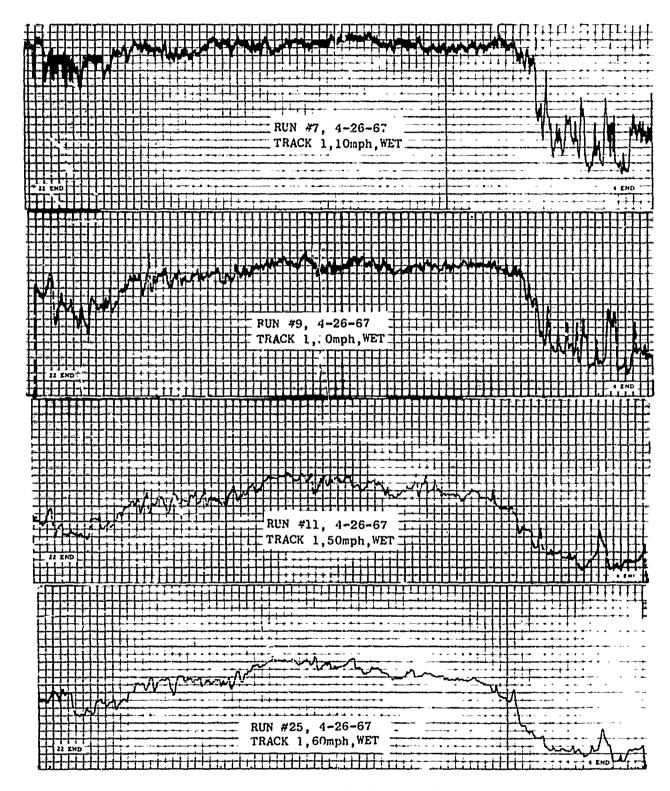
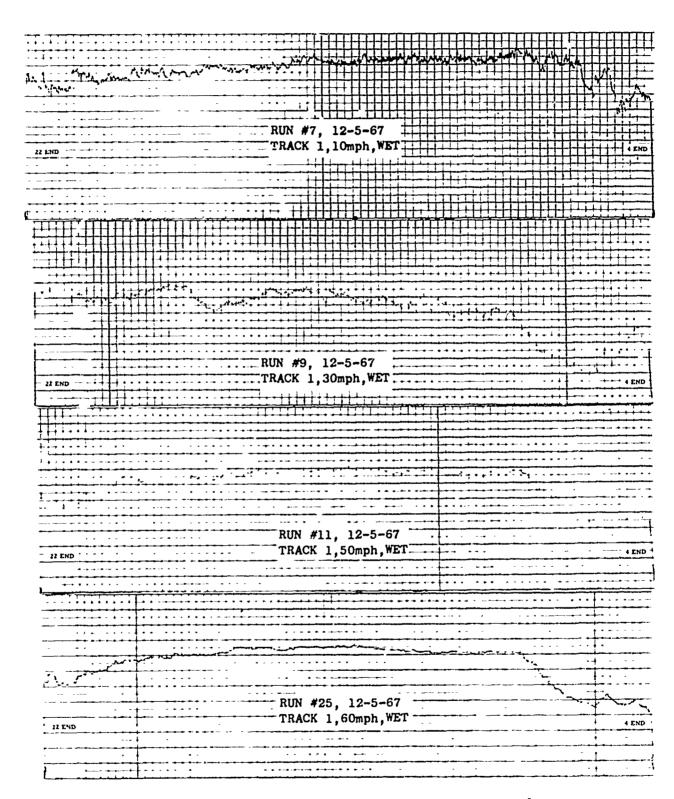
Track 1 (centerline) - The  $\mathrm{BFN}_{13}$  values for the postgrooving dry tests indicate a slight increase in friction values over the pregrooving values, pages 1-2 and 1-3. The values for the wet tests, pages 1-4 and 1-5, indicate a substantial increase in friction values at the higher test speeds of 50 and 60 mi/h. It is noted that the postgrooving analog friction traces are markedly smoother than the pregrooving traces.

BEFORE GROOVING - TRACK 1, CENTERLINE

AFTER GROOVING - TRACK 1, CENTERLINÉ

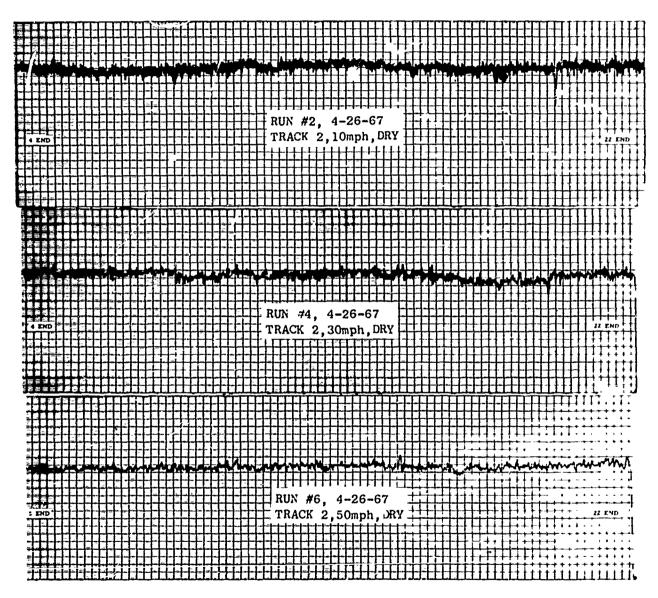
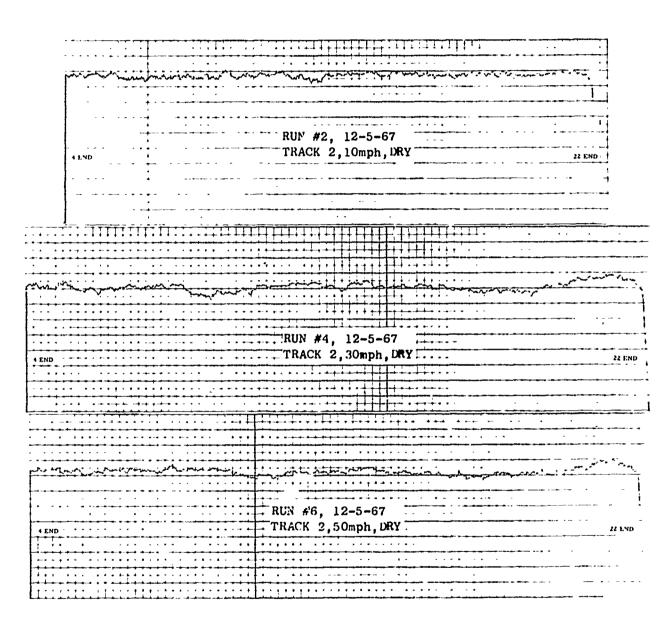
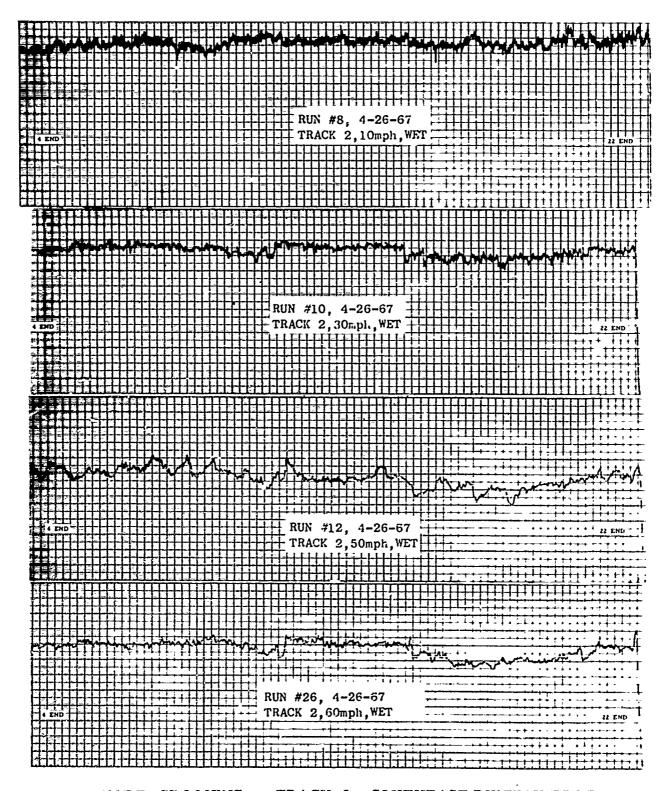
Track 2 (southeast runvay edge) - Since this track is near the edge of the runway and relatively free of rubber deposits and the polishing action of traffic, it would be expected that any friction value changes would be caused mainly by the grooves and that this portion of the runway would represent the original surface conditions exposed to the environment. As noted in the previous track, a slight increase in friction due to grooving is noted for the dry tests, pages 1-6 and 1-7; whereas a substantial increase is again noted especially for the higher 50- and 60-mi/h test speeds, pages 1-8 and 1-9. The slightly lower friction values for the 30-mi/h wet test are unexplainable except possibly due to seasonal friction effects, the thermodynamics of friction testing and/or the cooling effects of the test water on the tire. A definite smoothing of the postgrooving traces is noted.

BEFORE GROOVING - TRACK 2, SOUTHEAST RUNWAY EDGE

AFTER GROOVING - TRACK 2, SOUTHEAST RUNWAY EDGE

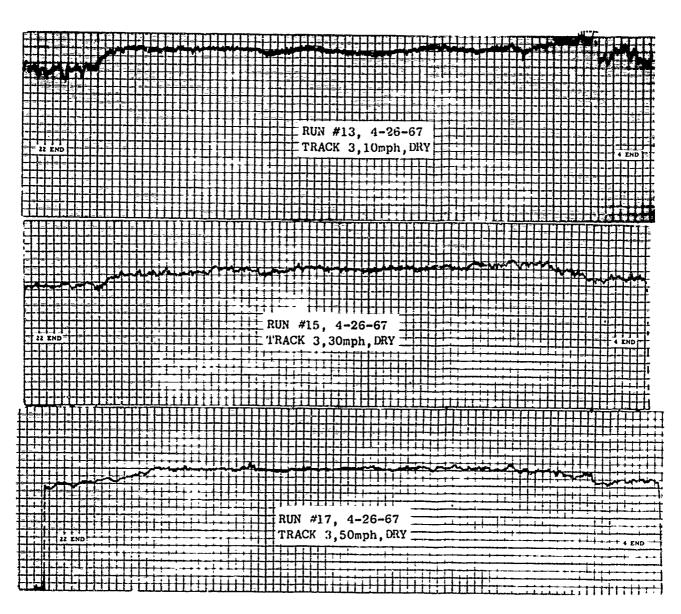
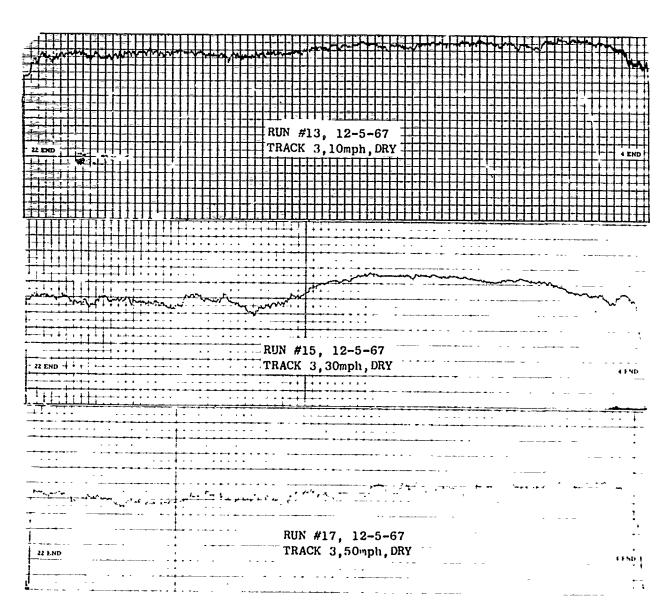
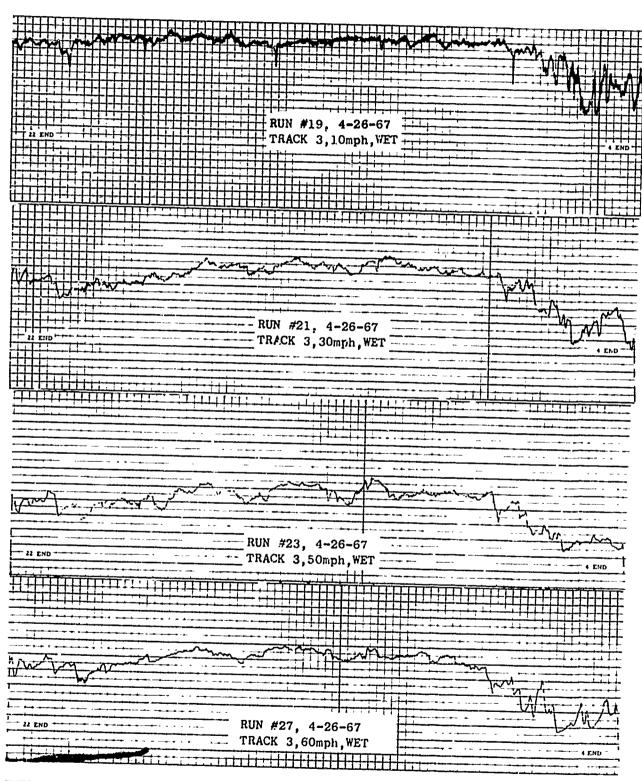
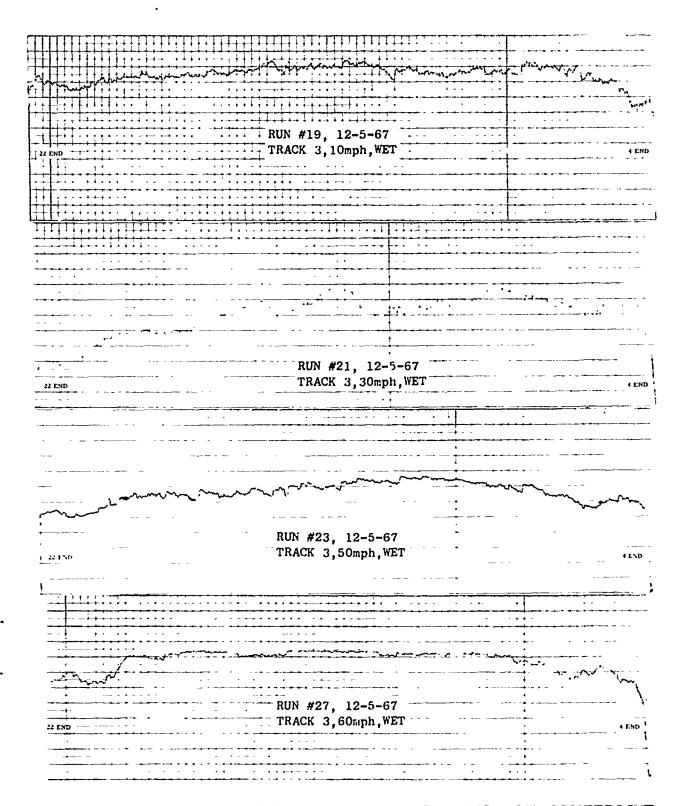
Track 3 (20 feet northwest of centerline) - The test data for this track, pages 1-10 through 1-13, show a slight decrease in postgrooving friction values except for the high speed 60-mi/h tests. Again, the before-grooving analog friction traces are not as smooth as the after-grooving traces.

BEFORE GROOVING - TRACK 3, 20 FT. NORTHWEST OF CENTERLINE

AFTER GROOVING - TRACK 3, 20 FT. NORTHWEST OF CENTERLINE

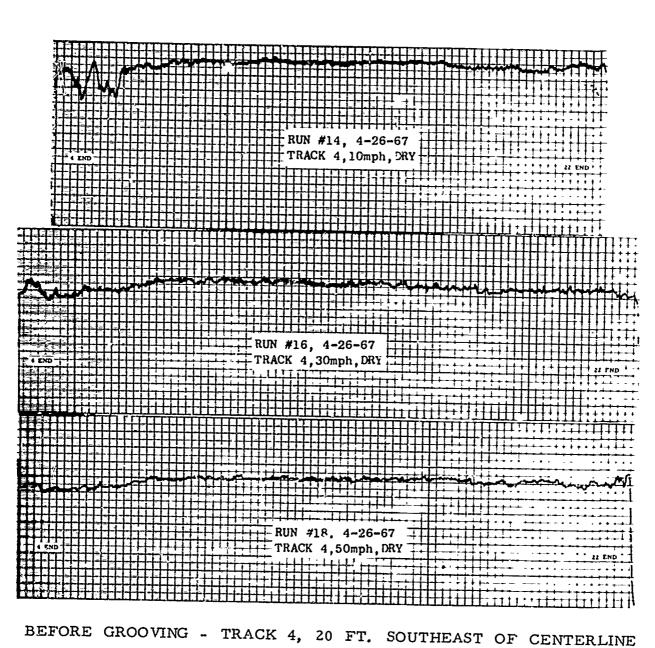
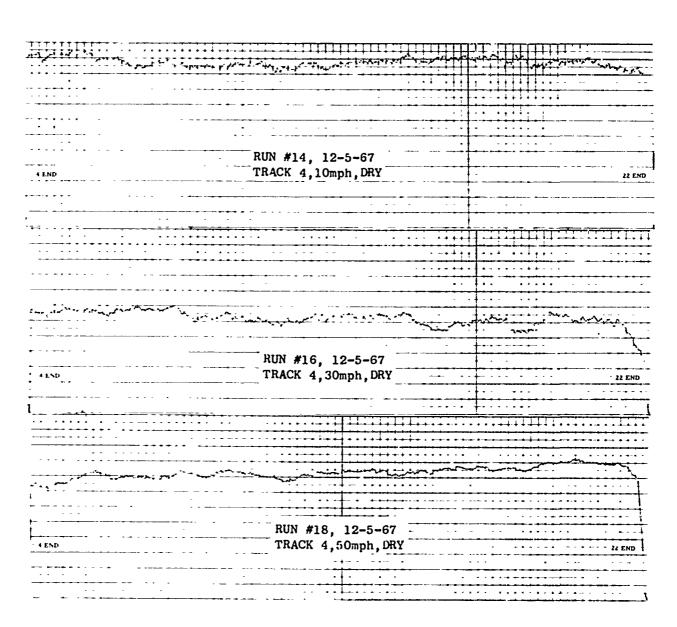
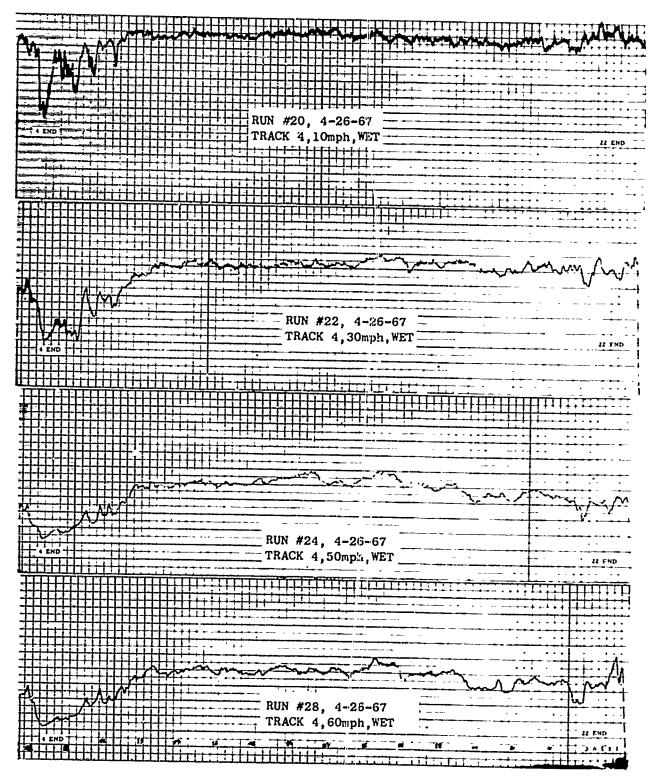
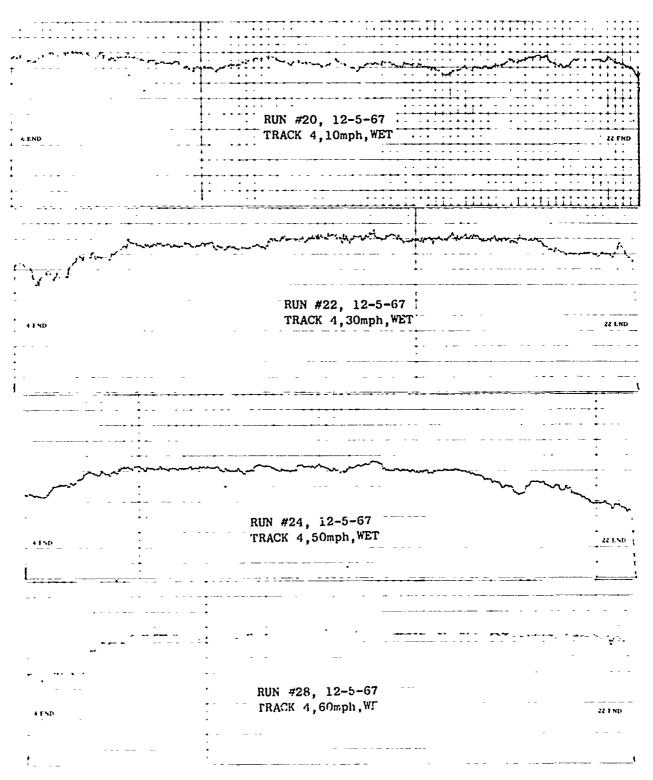
Track 4 (20 feet southeast of centerline) - Track 4 is the counterpart of Track 3 and produces friction data somewhat similar. This is borne out by an analysis of the data, pages 1-14 through 1-17, except that the 30- and 50-mi/h after-grooving friction values offer a substantial increase over the before-grooving values in addition to the 60-mi/h increase.

BEFORE GROOVING - TRACK 4, 20 FT. SOUTHEAST OF CENTERLINE

AFTER GROOVING - TRACK 4, 20 FT. SOUTHEAST OF CENTERLINE

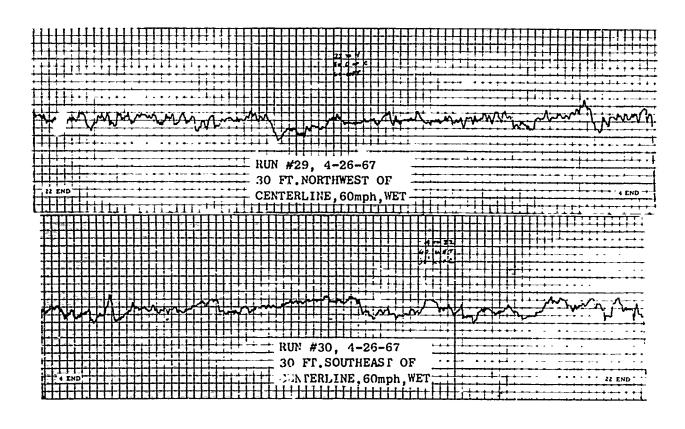
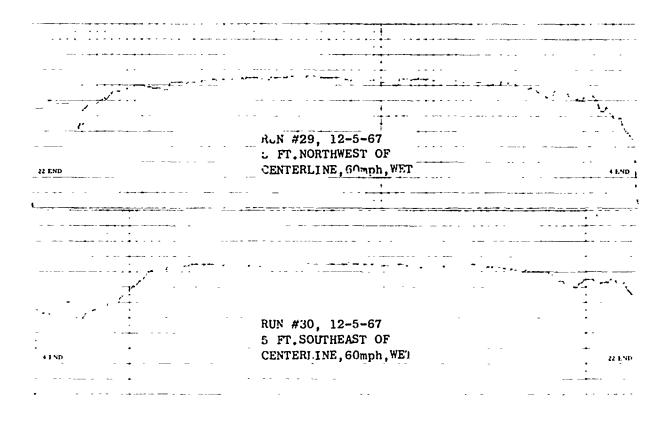
Analysis of the ungrooved runway data for the test paths 30 feet each side of the centerline, shown in the Appendix, pages 1-18, indicates that they are very similar to the data produced at the runway edge, shown in page 1-8. This indicates that the heavily rubber-contaminated areas do not extend as far as 30 feet from the runway centerline.

The data for the postgrooving test runs, 5 feet each side of the centerline, shown in the Appendix, page 1-19, indicate a marked similarity to the adjacent 60-mi/h data for Test Tracks 1, 3, and 4, shown in page 1-5, 1-13, and 1-17, respectively.

MISCELLANEOUS BEFORE GROOVING 60 mph WET TESTS

MISCELLANEOUS AFTER GROOVING 60 mph WET TESTS
